1. REPORT NO.		2. GOVERNMENT ACCESSION NO.		3. RECIPIENT'S CATALOG NO.	
4. TITLE AND SUBTITLE Evaluation of the Ion Exchange Landslide Correction Technique				5. REPORT DATE January 1973

9. PERFORMING ORGANIZATION NAME AND ADDRESS Materials and Research Department California Division of Highways Sacramento, California 95819				10. WORK UNIT NO.

Final Report
M&R No. 632116
D-5-38

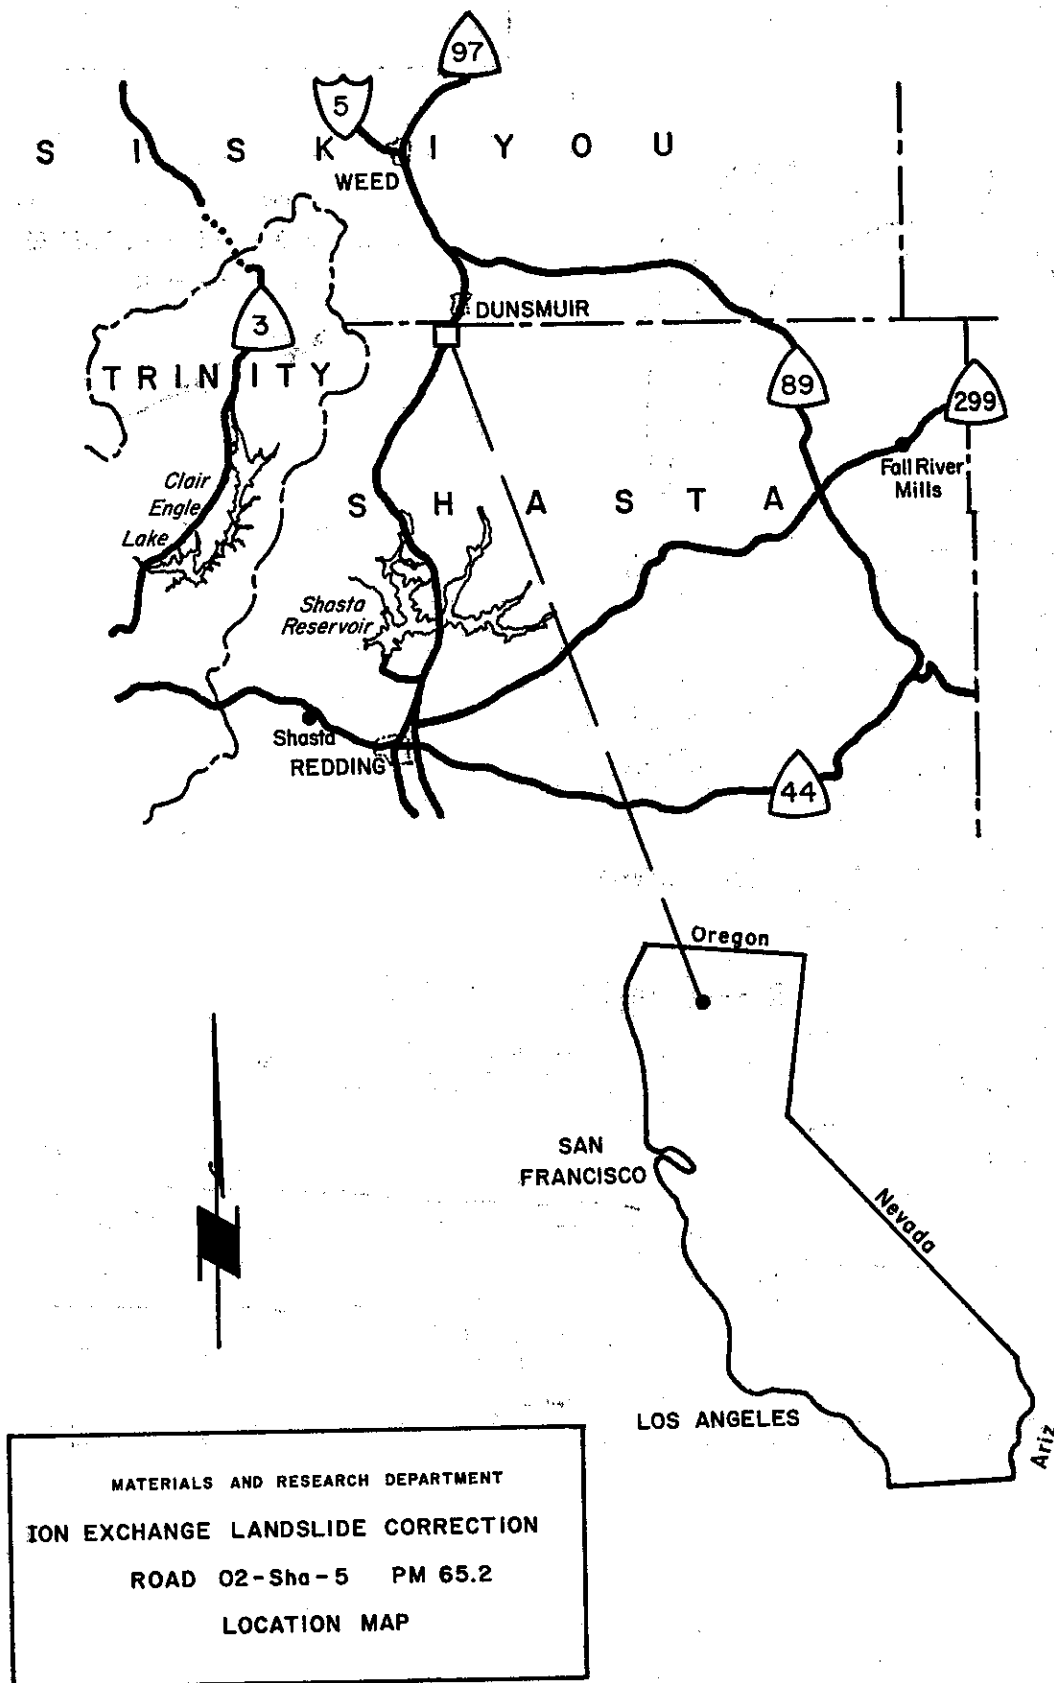
The test site is located on Road 02-Sha-5, Post Mile 65.2, approximately three miles south of Dunsmuir. See Figure 1 for the location map.

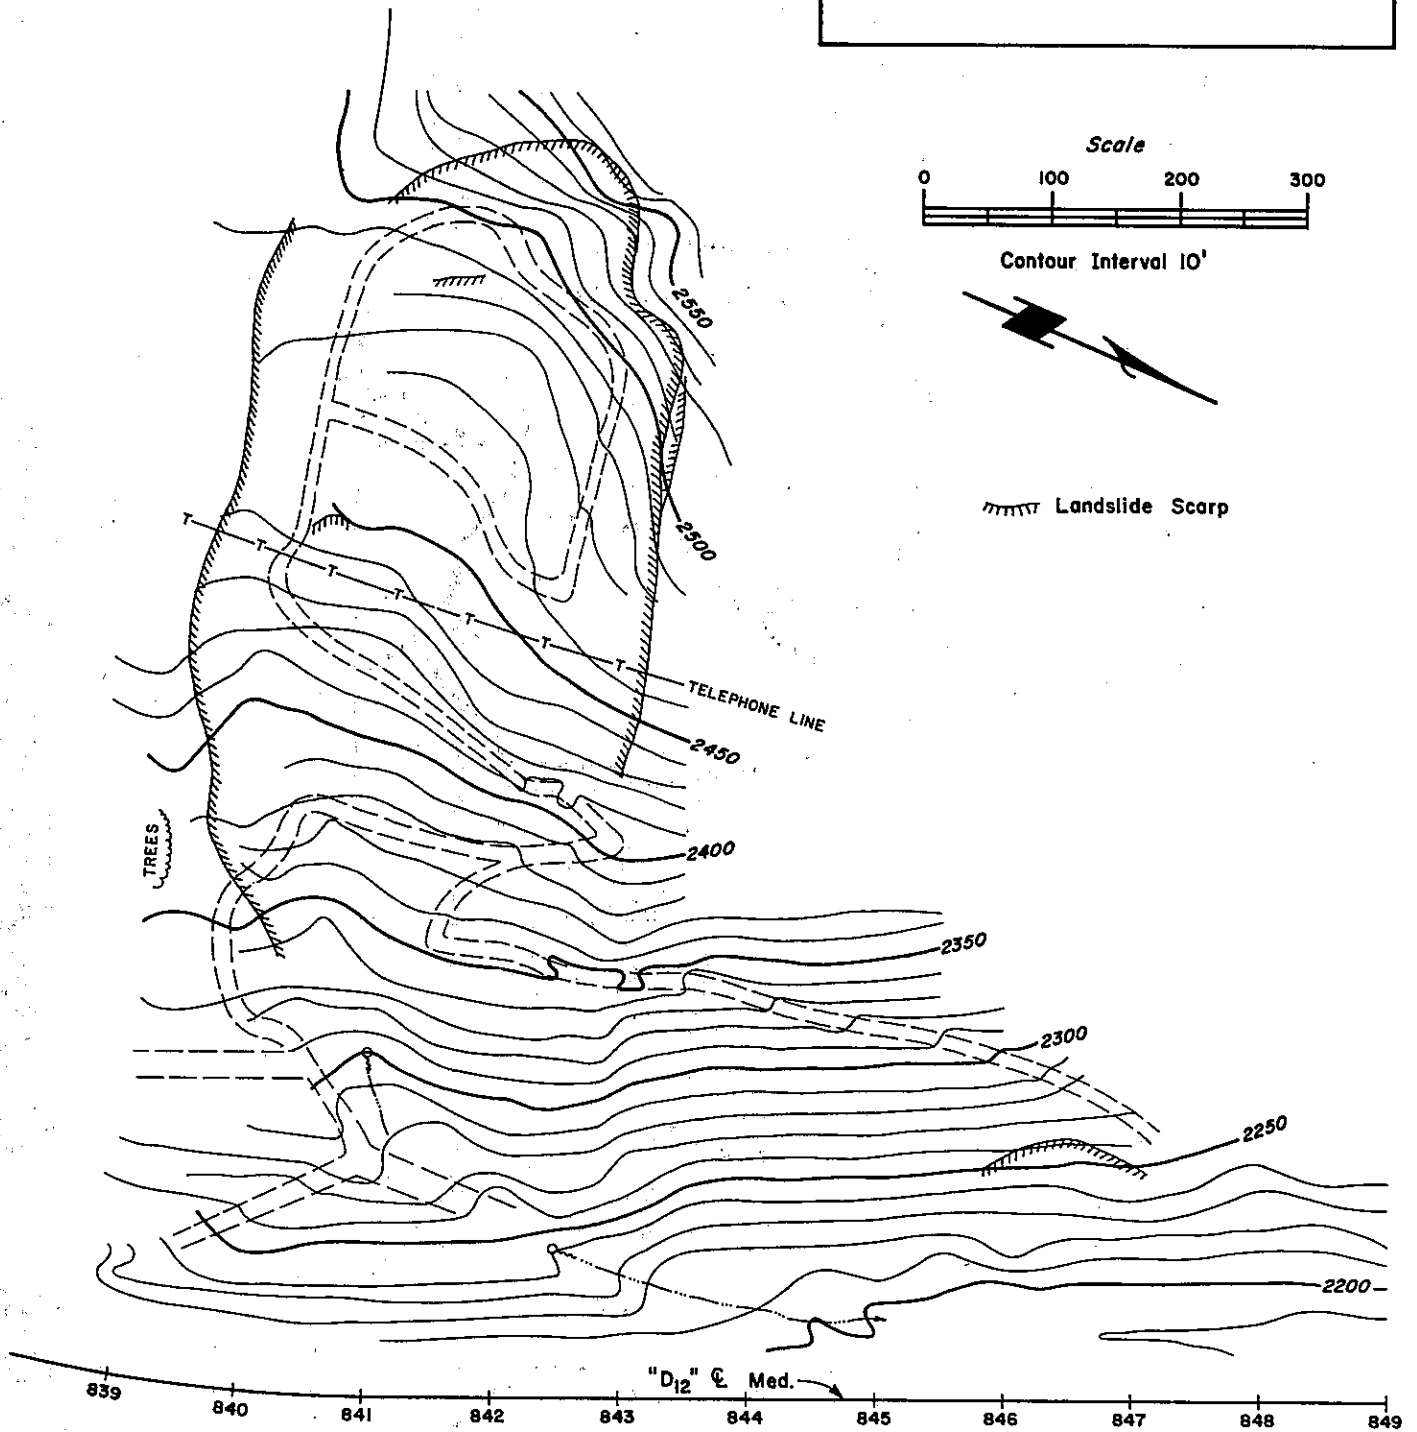
The slide which is pictured on Plates 1 and 2, is approximately 900 feet long and 400 feet wide with a maximum thickness of 100 feet. Figure 2 shows the topography at the time of this correction. It appears to be a very old landslide that was reactivated by construction of the highway cut in 1959. Correction work completed during construction consisted of slope flattening and the installation of horizontal drains. Although actual measurements have not been taken subsequent to construction, the movement appears to have continued since that time. The wet winters of 1964-65 and 1968-69 appear to have resulted in particularly large movements and the destruction of the horizontal drains installed during construction.

MATERIALS AND RESEARCH DEPARTMENT
ION EXCHANGE LANDSLIDE CORRECTION
ROAD 02-Sha-5 PM 65.2
PLAN

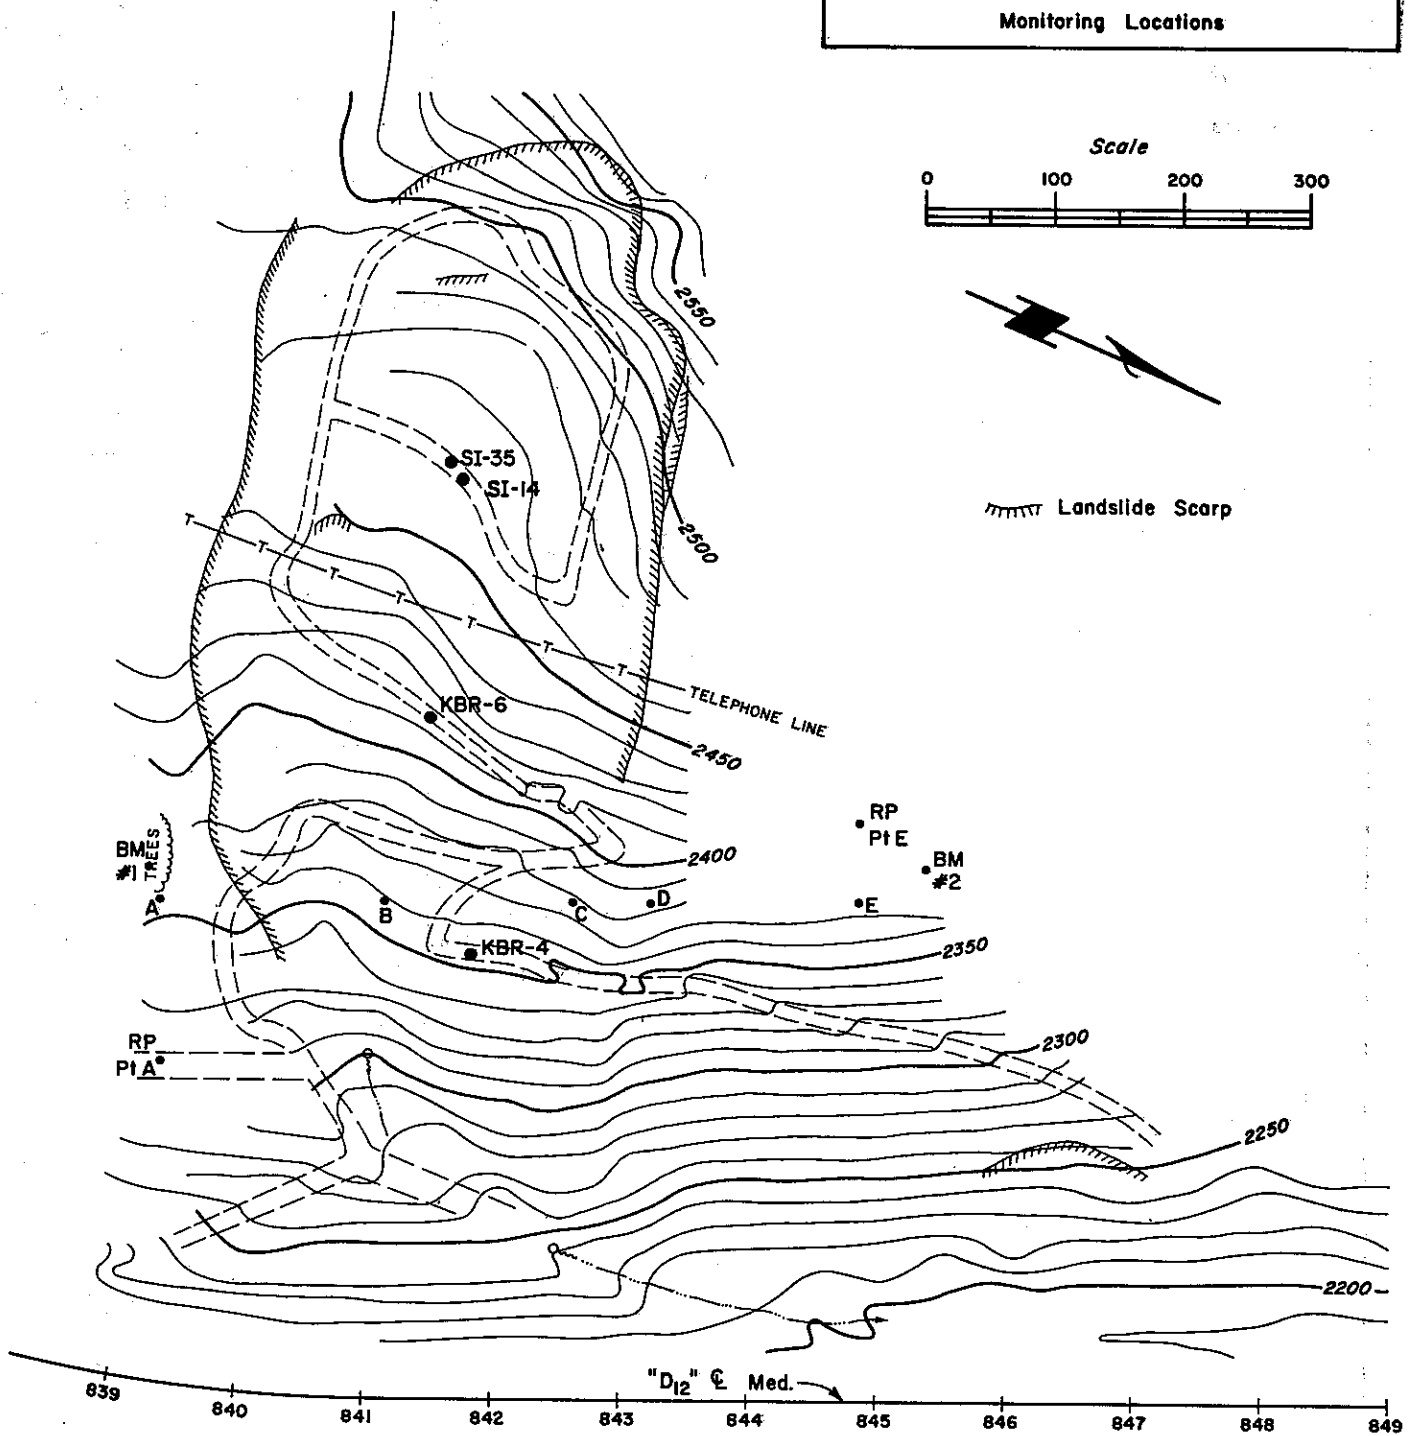
A row of points were established across the landslide on a line and the elevation of each point was established. Each end of the line was tied into a bench mark and a reference point. These points are all included on Figure 5 and are labeled A, B, C, D, E, BM#1, BM#2, RP PtA and RP PtE. This line was established and located in July of 1970 and was checked for changes in horizontal alignment and elevation in February of 1971, prior to treatment, and in March of 1972, nearly one year after treatment.

MATERIALS AND RESEARCH DEPARTMENT
ION EXCHANGE LANDSLIDE CORRECTION
ROAD 02-Sha-5 PM 65.2
PLAN
Monitoring Locations
